<b>Site Visit Report</b>		Project: <b>WO-LT0082AMD2 Sardar Kabuli Girls' High School Fire Door Replacement QA Services</b>	
Location: <b>Dar-ul- aman Road, Qala-e- Raees, Kabul, Afghanistan</b>		Contract Number: <b>AID-306-TO-15-00014</b>	
Inspection Date: <b>March 27, 2016</b>		Coordinates: Latitude: <b>34.484997 N°</b> Longitude: <b>69.137351 E°</b>	
Inspectors:

## EXECUTIVE SUMMARY

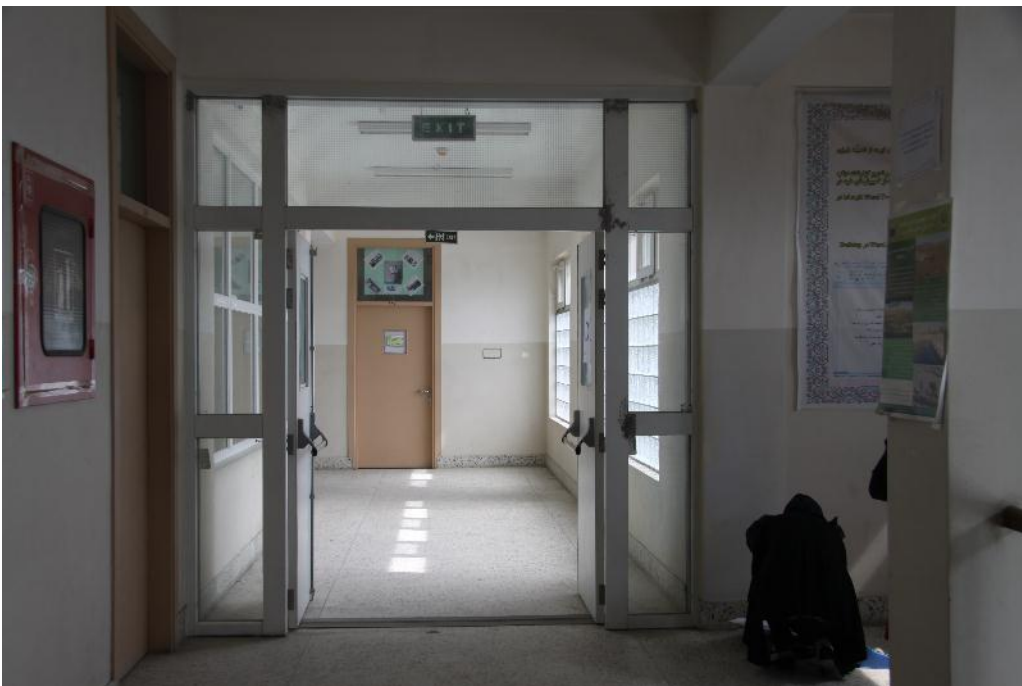
7. Each door panel of the existing units is supported by four hinges, and the new units are designed with only three required hinges per door panel. Therefore, when the new three hinge doors are installed, there will be one empty hinge.

**Figure 2.** View of door #1 hinges FK, 2016-03-27

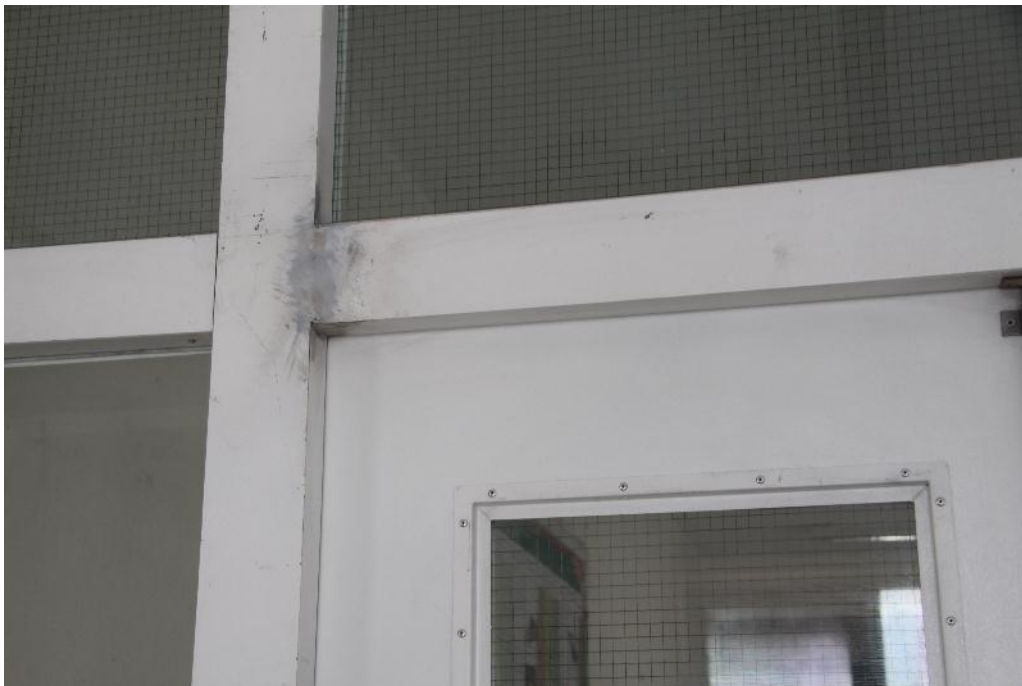
2. A second reason for the replacement of the units is that field adjustments were made to the fire-rated door units. Because of a procurement issue, the door units that were ordered and received were too large to fit in the existing openings. The contractor made cuts and re-welds of the frames in order to fit the doors into the opening, but the contractor did not realize that the field modifications of the door frames voided the manufacturer's fire rating of the certifications of the door units. Examples of these cuts/re-welds are numerous, and are documented in the photos provided in this report.

**Figure 4.** Fire rating voided because of field modifications, i.e. cut & weld, FK, 2016-03-27

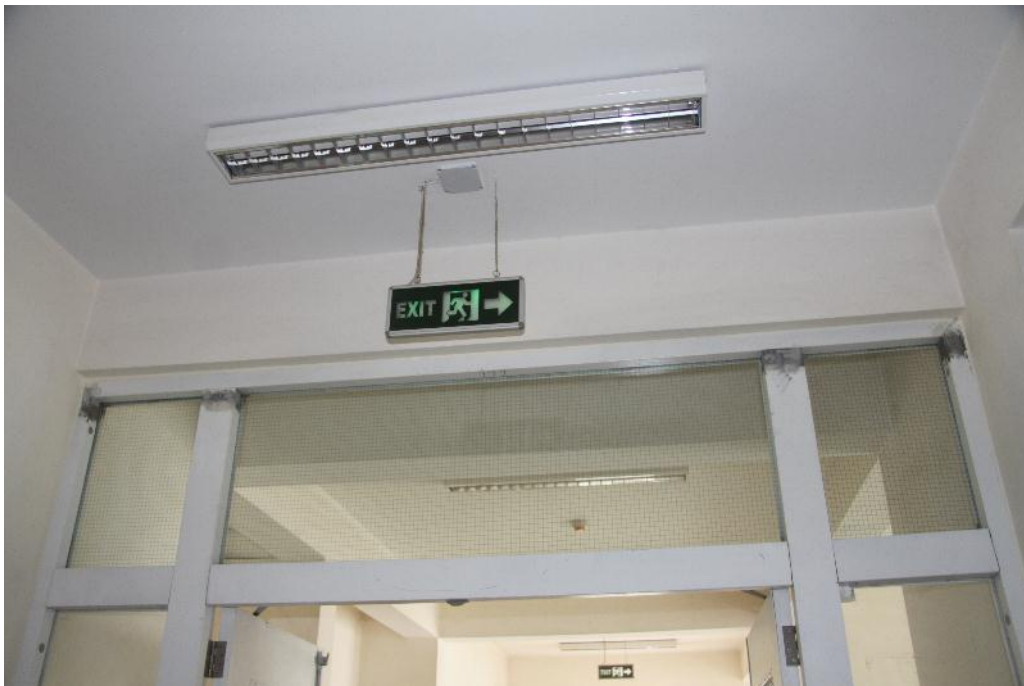
**Figure 8.** View of frame Fire-Rating Voided Because of Field Welding, FK, 2016-03-27

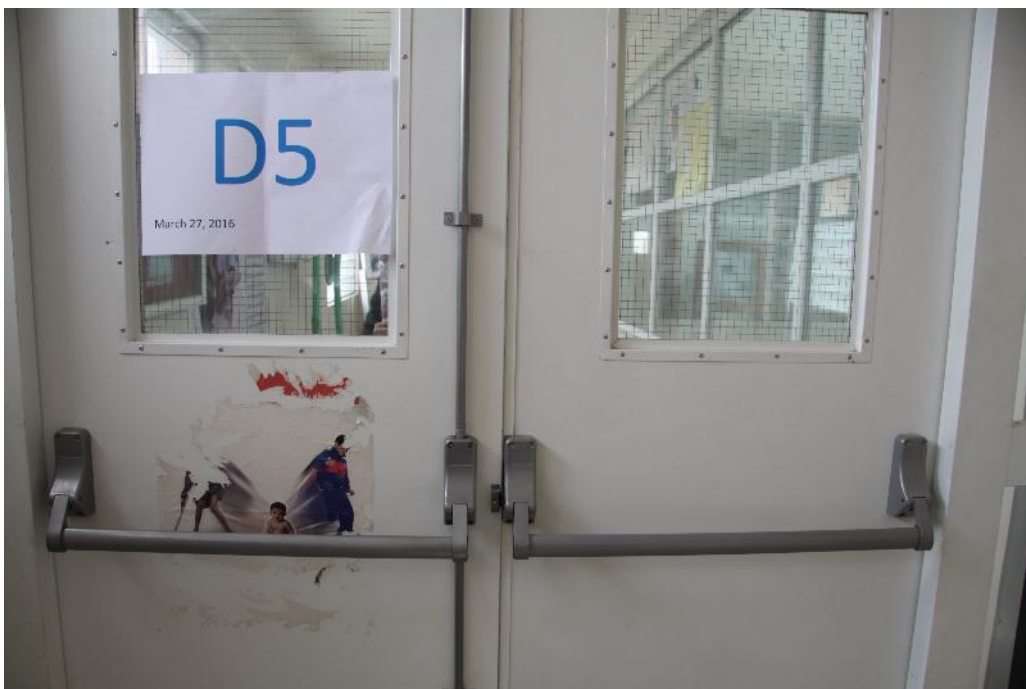
5. The existing door panels, door closures, handle sets, panic hardware and door stops are in good condition.
6. Door units did not have any broken or cracked glass panes.

**Figure 10.** View of Typical installed panic push bar hardware with door stops, FK, 2016-03-27

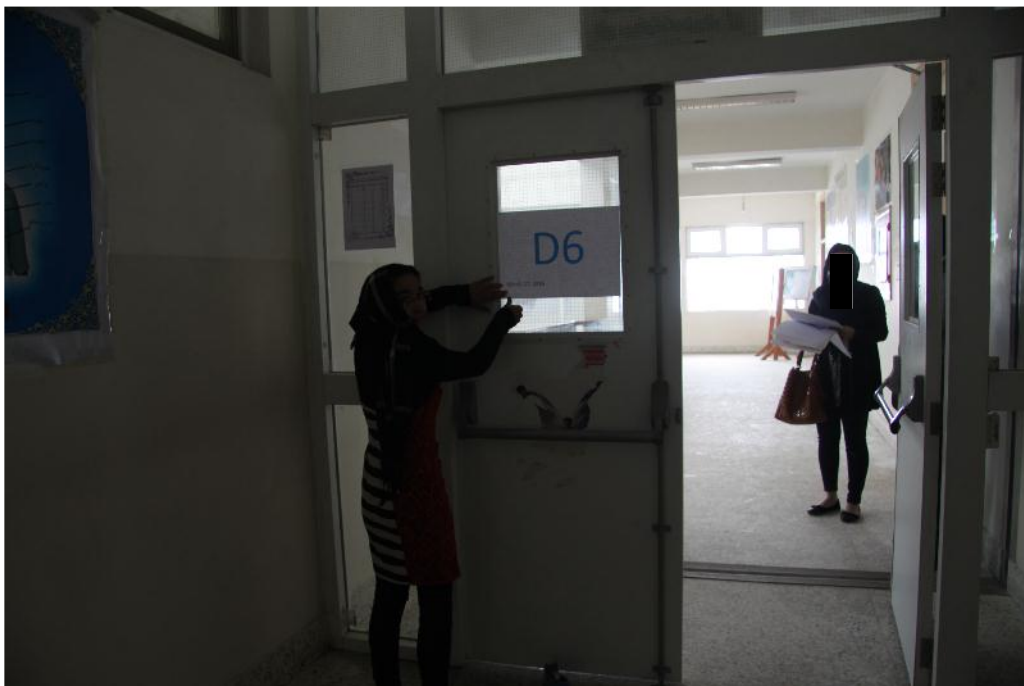
8. All door panels are hung and are swinging in the correct directions per the drawings.
9. The walls are painted with two-toned plaster finish.
10. The ceilings and ceiling offsets are painted with a single color plaster finish.

**Figure 12:** Swings checked against plans, FK, 2016-03-27

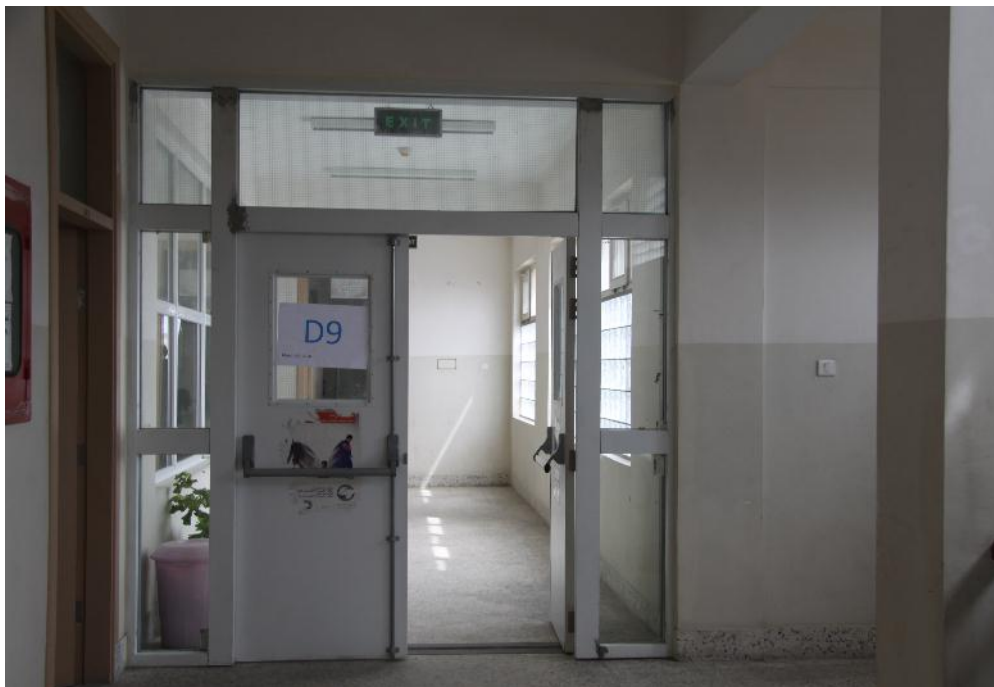
**Figure 18.** Door #9 opening direction, FK, 2016-03-27

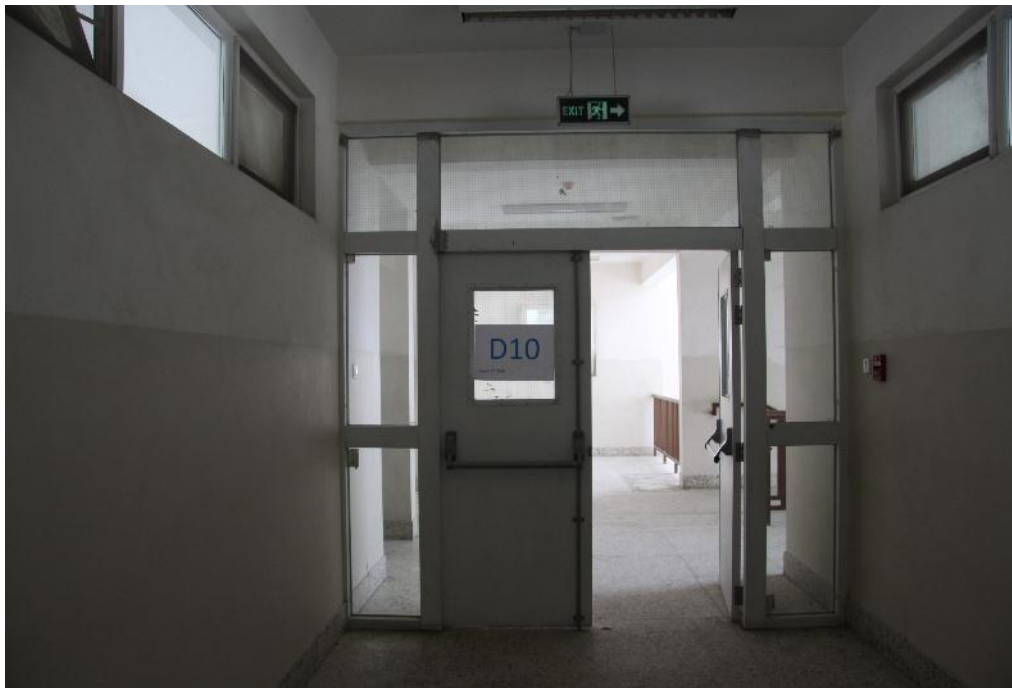
**Figure 19.** Swings checked against plans, FK, 2016-03-27

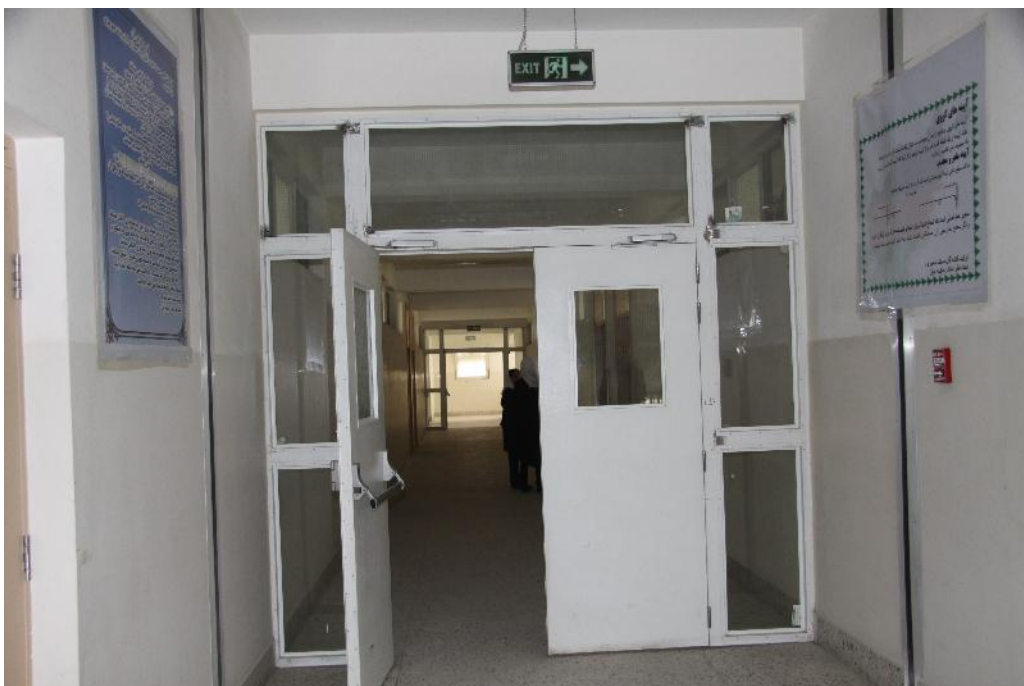
**Figure 22.** Swings checked against plans, FK, 2016-03-27

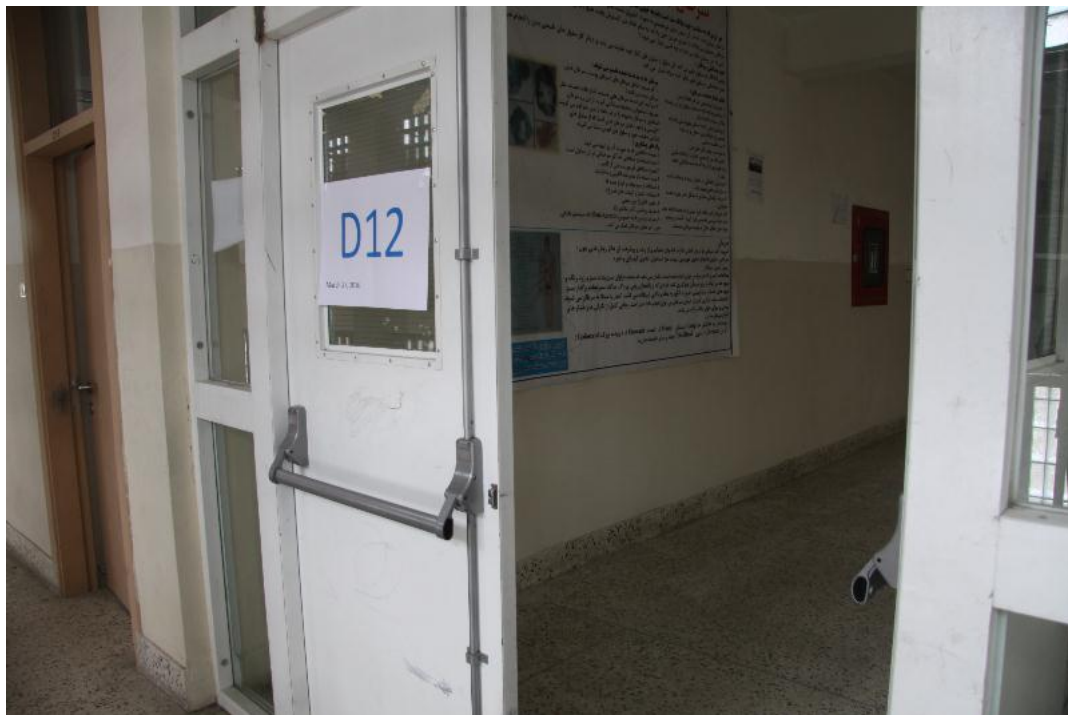
**Figure 24.** Swings checked against plans, FK, 2016-03-27

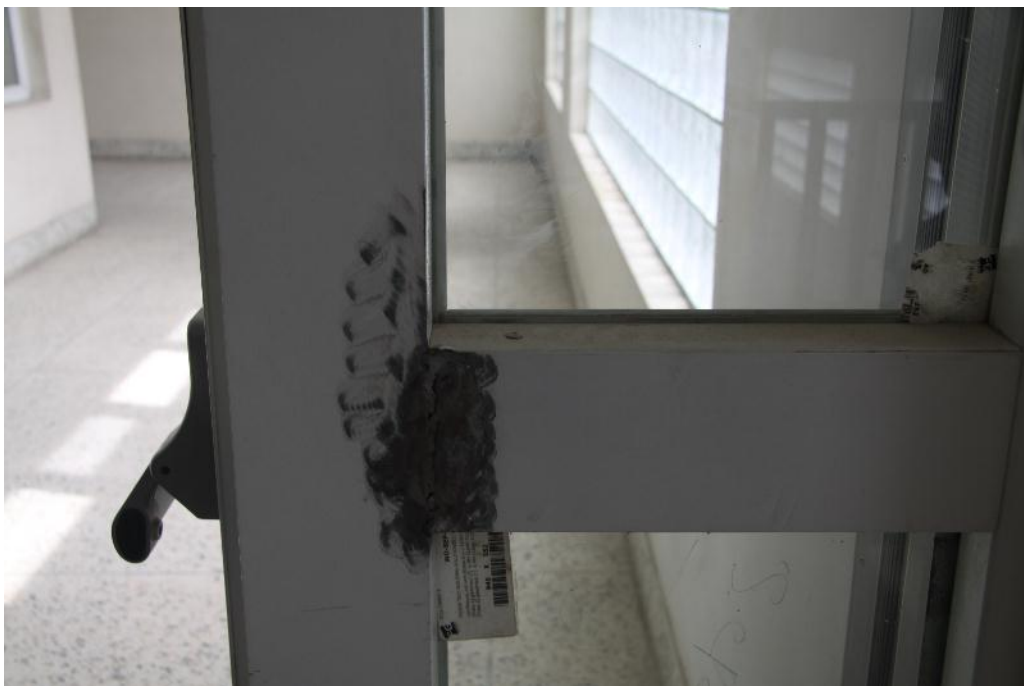
**Figure 26.** Welded parts door #13, FK, 2016-03-27

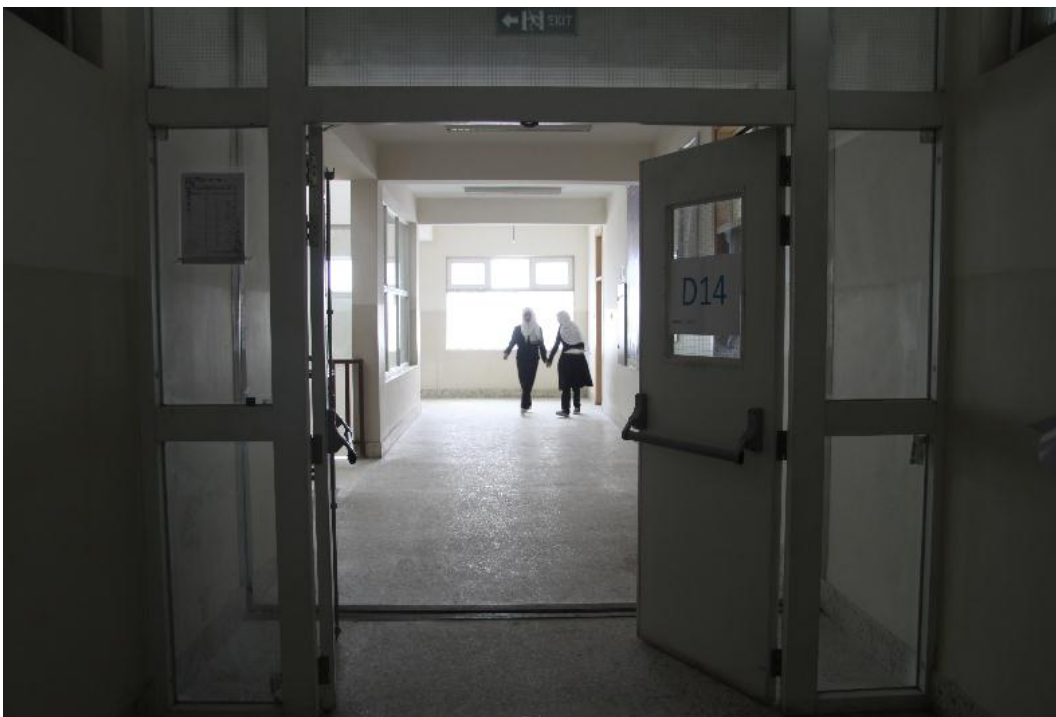
**Figure 28.** Swings checked against plans door #14, FK, 2016-03-27

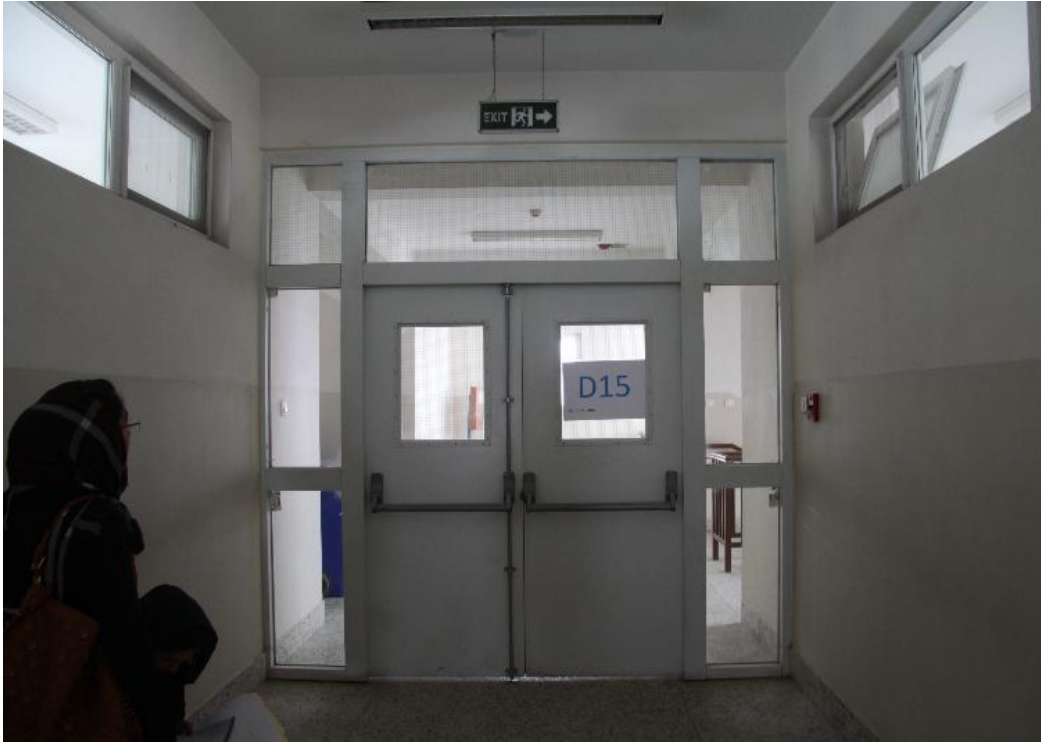
14. Each door unit is identified within the photos by a printed temporary number sign of the door unit which matches the school as-built drawings.
15. The ceiling offset of door #15 is plaster cracked as an existing condition. No contractor corrective action required for this pre-existing condition.

**Figure 29.** View of Front side door #15, FK, 2016-03-27

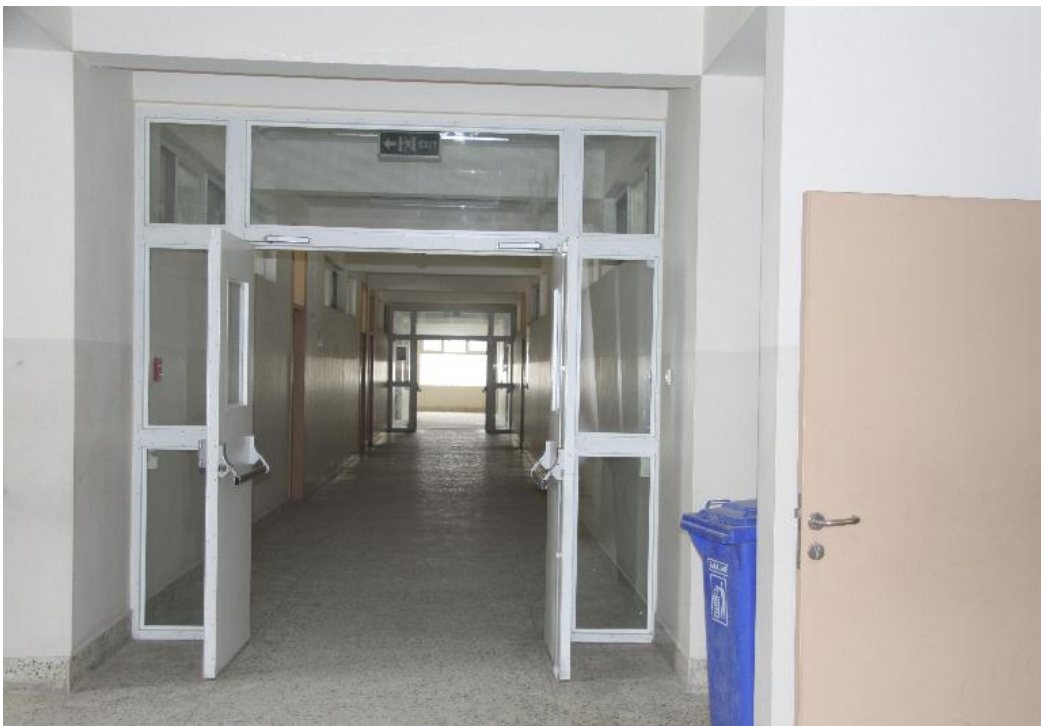
**Figure 30.** Swings checked against plans door #15, FK, 2016-03-27

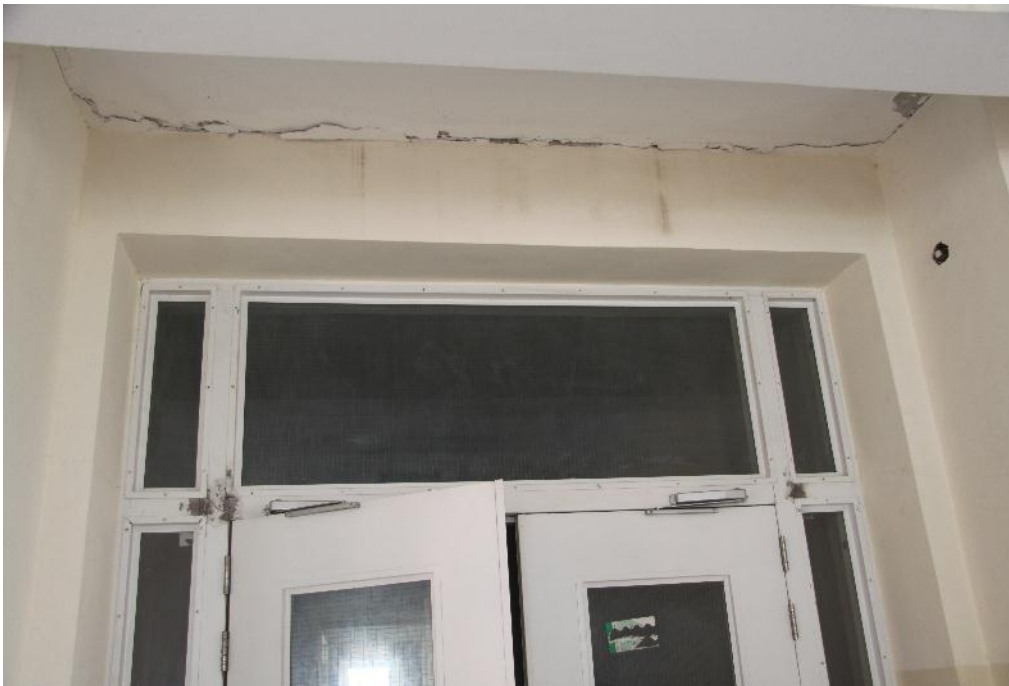
**Figure 32.** Existing condition of door #16, FK, 2016-03-27

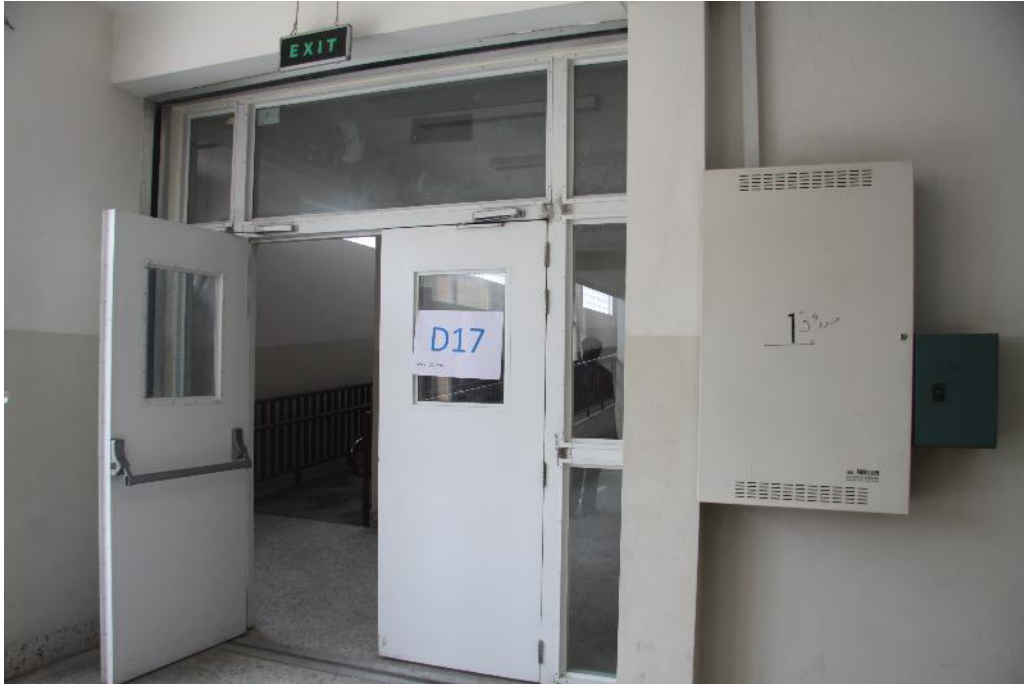
**Figure 33.** Swings checked against plans door #17, FK, 2016-03-27

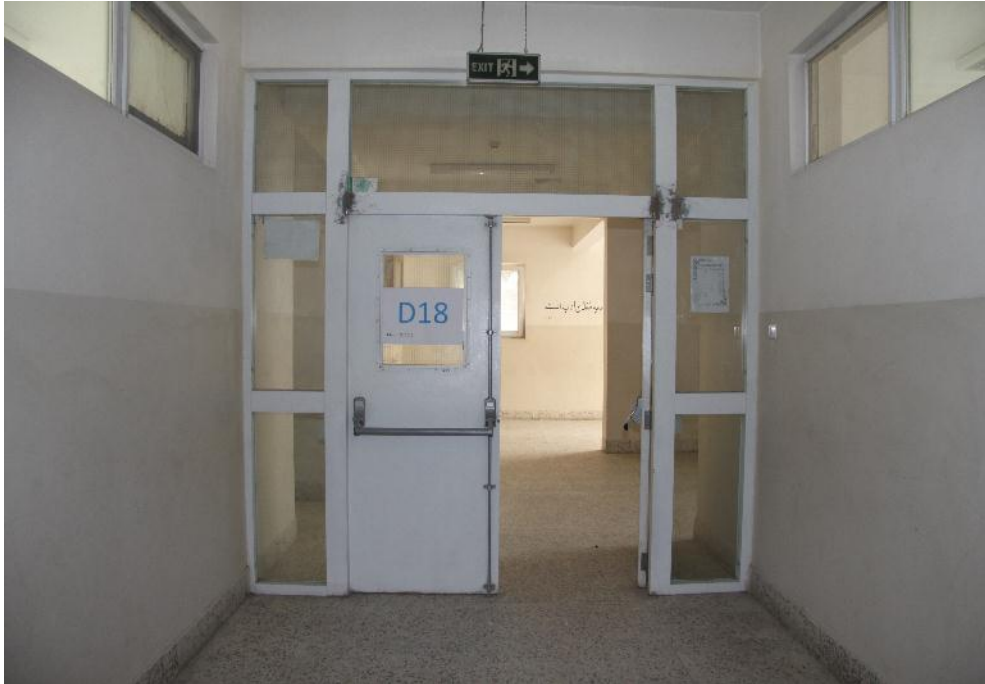
**Figure 35.** Swings checked against plans door #18, FK, 2016-03-27

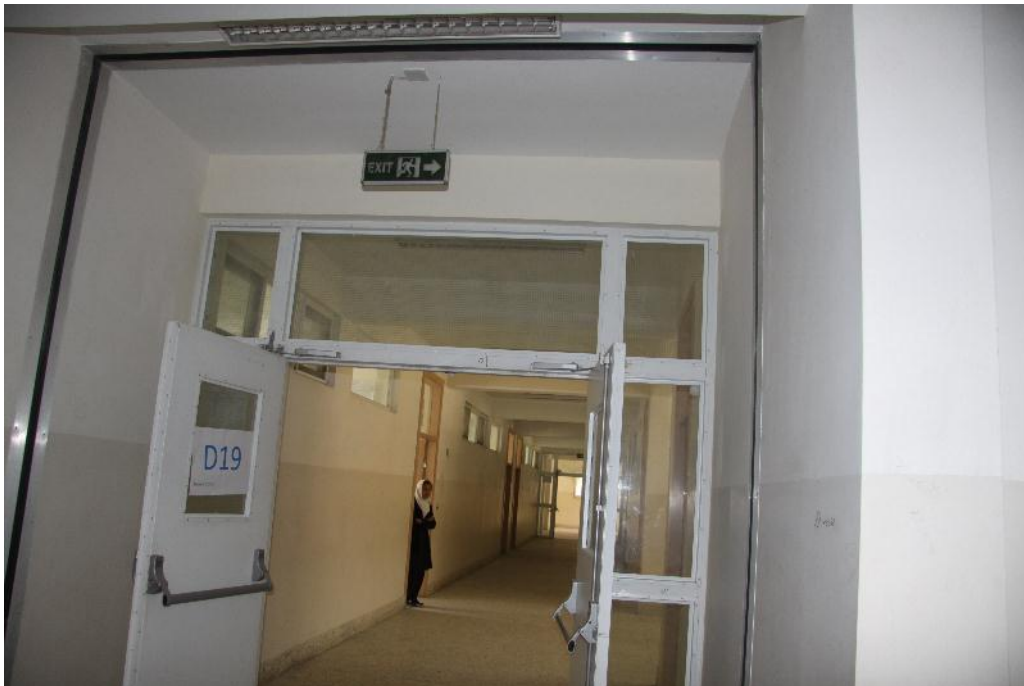
**Figure 38.** Swings checked against plans door #19, FK, 2016-03-27

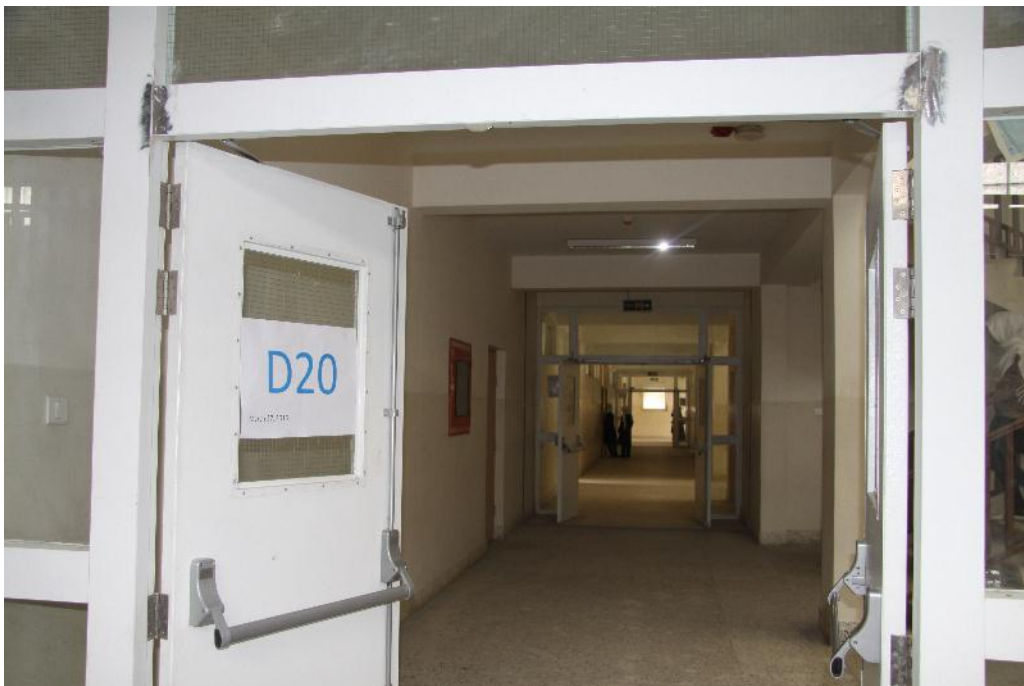
**Figure 40.** Swings checked against plans door #20, FK, 2016-03-27

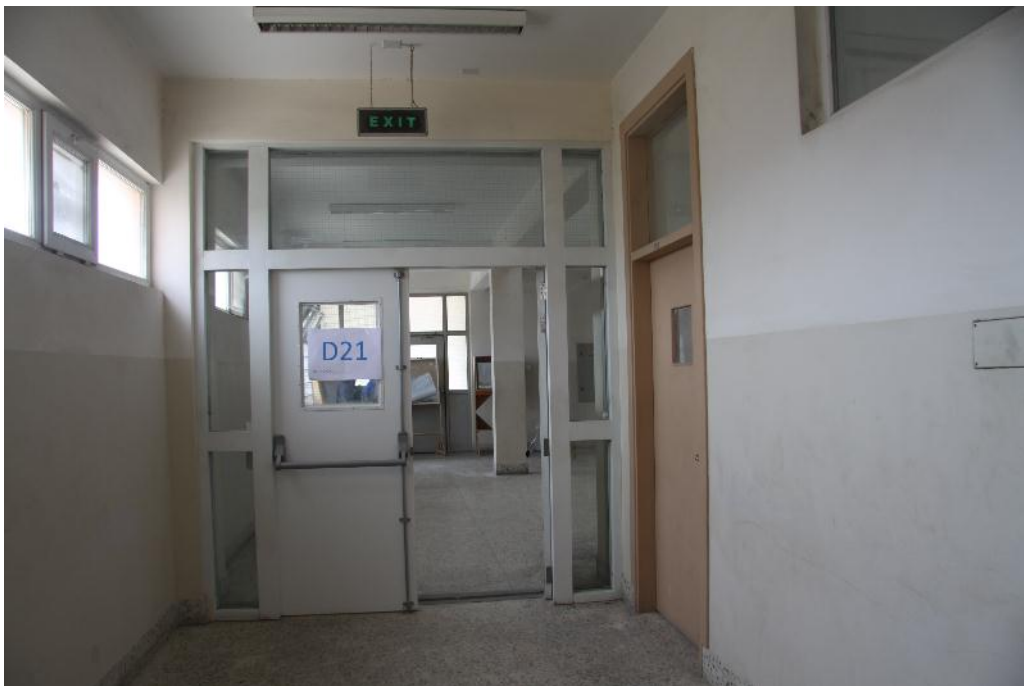
**Figure 42.** Swings checked against plans door #21, FK, 2016-03-27

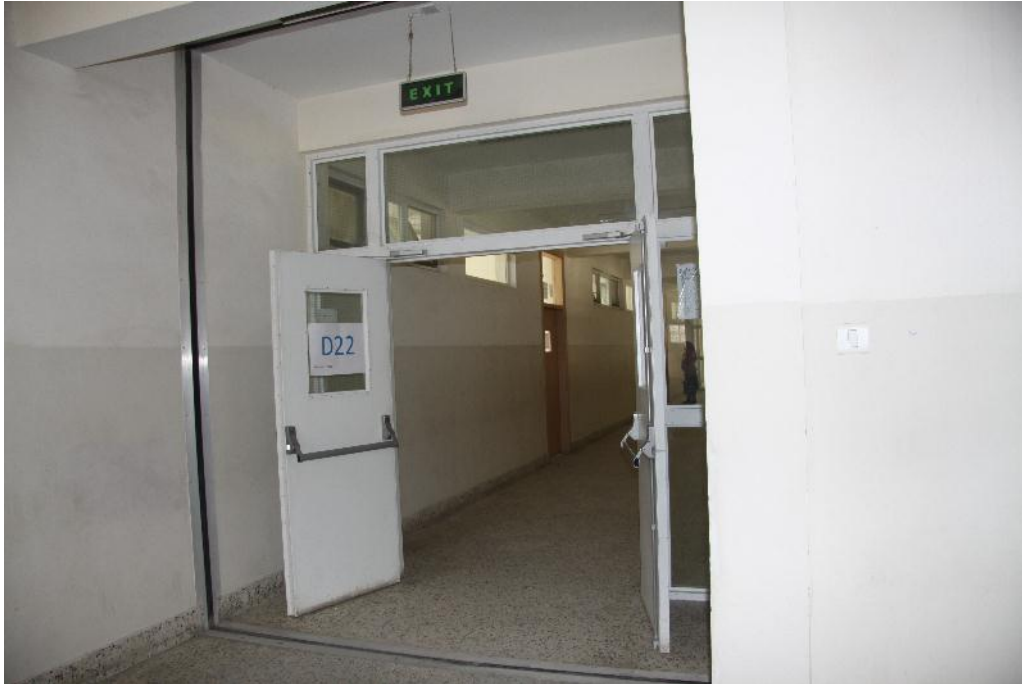
**Figure 43.** Swings checked against plans door #22, FK, 2016-03-27

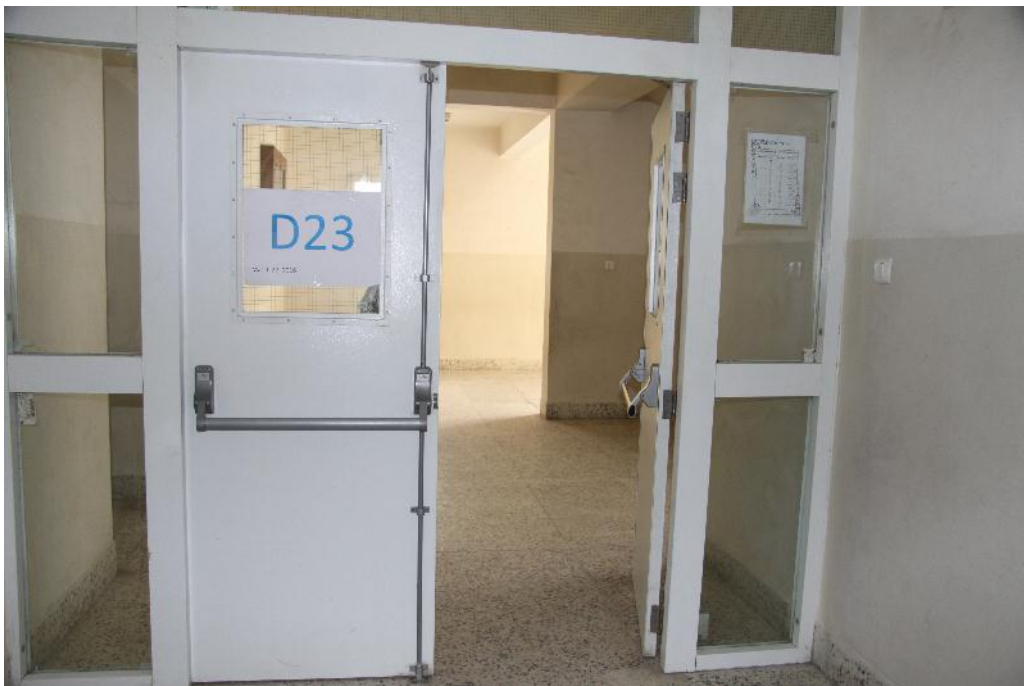
**Figure 46.** Swings checked against plans door #23, FK, 2016-03-27
